Bubble Formation on Electroplated Parts. Finding Defect Causes after Climate Testing

May, 2012

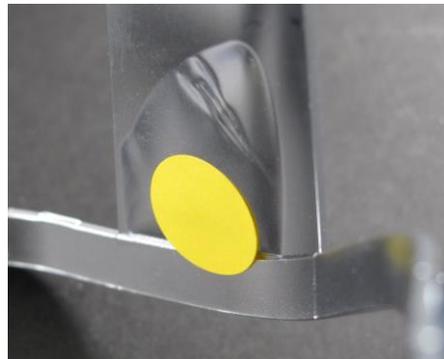
PC/ABS parts that were apparently well electroplated showed a distinct bubble formation in some areas after temperature cycling test (Fig. 1). Because of that, the entire production batch had to be stopped.

Fig. 1: Electroplated part with bubble formation.

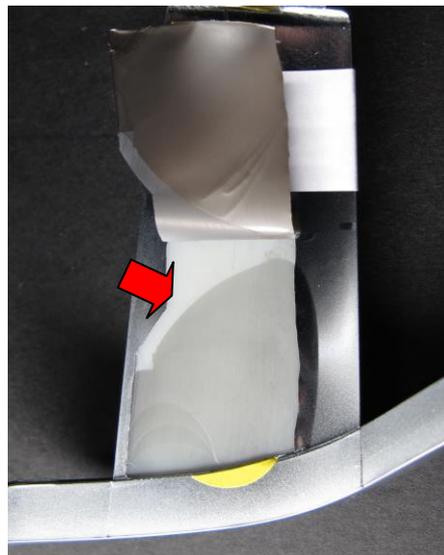
A typical bubble was opened at the Analytik Service Obernburg. The polymer surface below the bubble appears to be darker than on the freshly pulled-off reference zone (red arrow in Fig. 2). In the bubble area, there is only little polymer adhesion on the metal. Its adhesion in the reference zone, however, is so high that a part of the polymer was teared-off during pulling-off the metal layer – the underside of the metal is covered by numerous polymer deposits (Fig. 3). In a subsequent step, the polymer in the reference zone was chemically removed so that the metal underside was uncovered (Figs. 4 and 5); here, a cavern structure in varying degree can be seen.

Fig. 2: Opened bubble

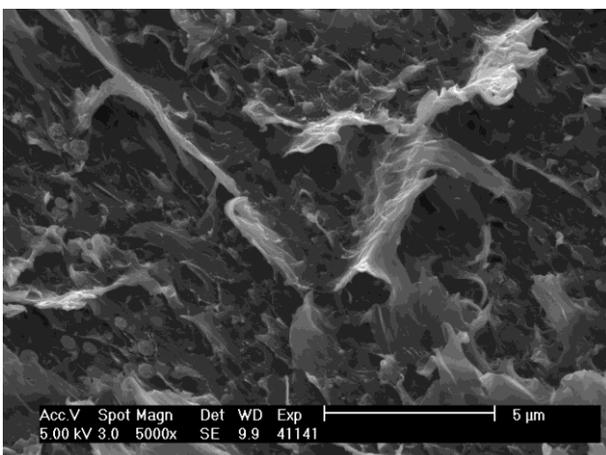
Fig. 3: Metal underside of the reference zone with polymer deposits.

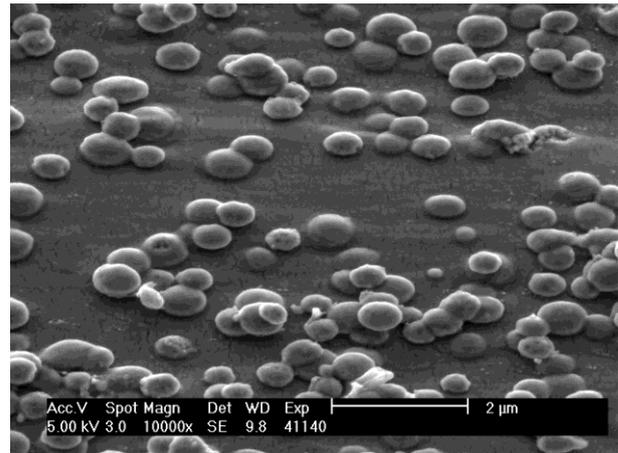
Fig. 4: Metal underside in the **bubble zone** with relatively few anchor points.

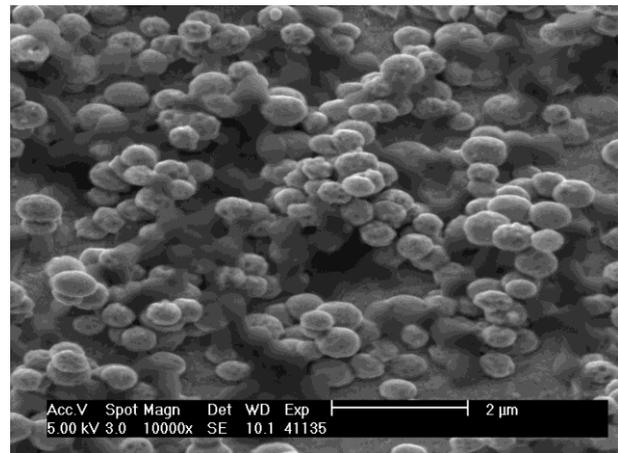
Fig. 5: Cleaned metal underside in the reference zone (many calottes result in a close connection with the polymer).

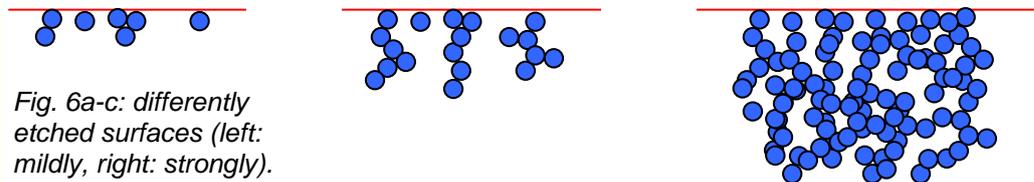
During electroplating, at first the butadiene component of the ABS is oxidized in an etch process. This leads to a formation of a cavern structure being filled with metal in the following process steps – and this causes the anchoring. If the etching treatment is too little, (Fig. 6a), too few anchor points are formed. In case of a too strong etching (Fig. 6c), too few polymer webs remain – and this also results in a strength reduction.

Fig. 6a-c: differently etched surfaces (left: mildly, right: strongly).
